Wetland and Waterbodies Delineation Report Borrego Solar Systems, Inc.

153 YMCA Road
Amsterdam, New York

December 2020
Project No. 2003593

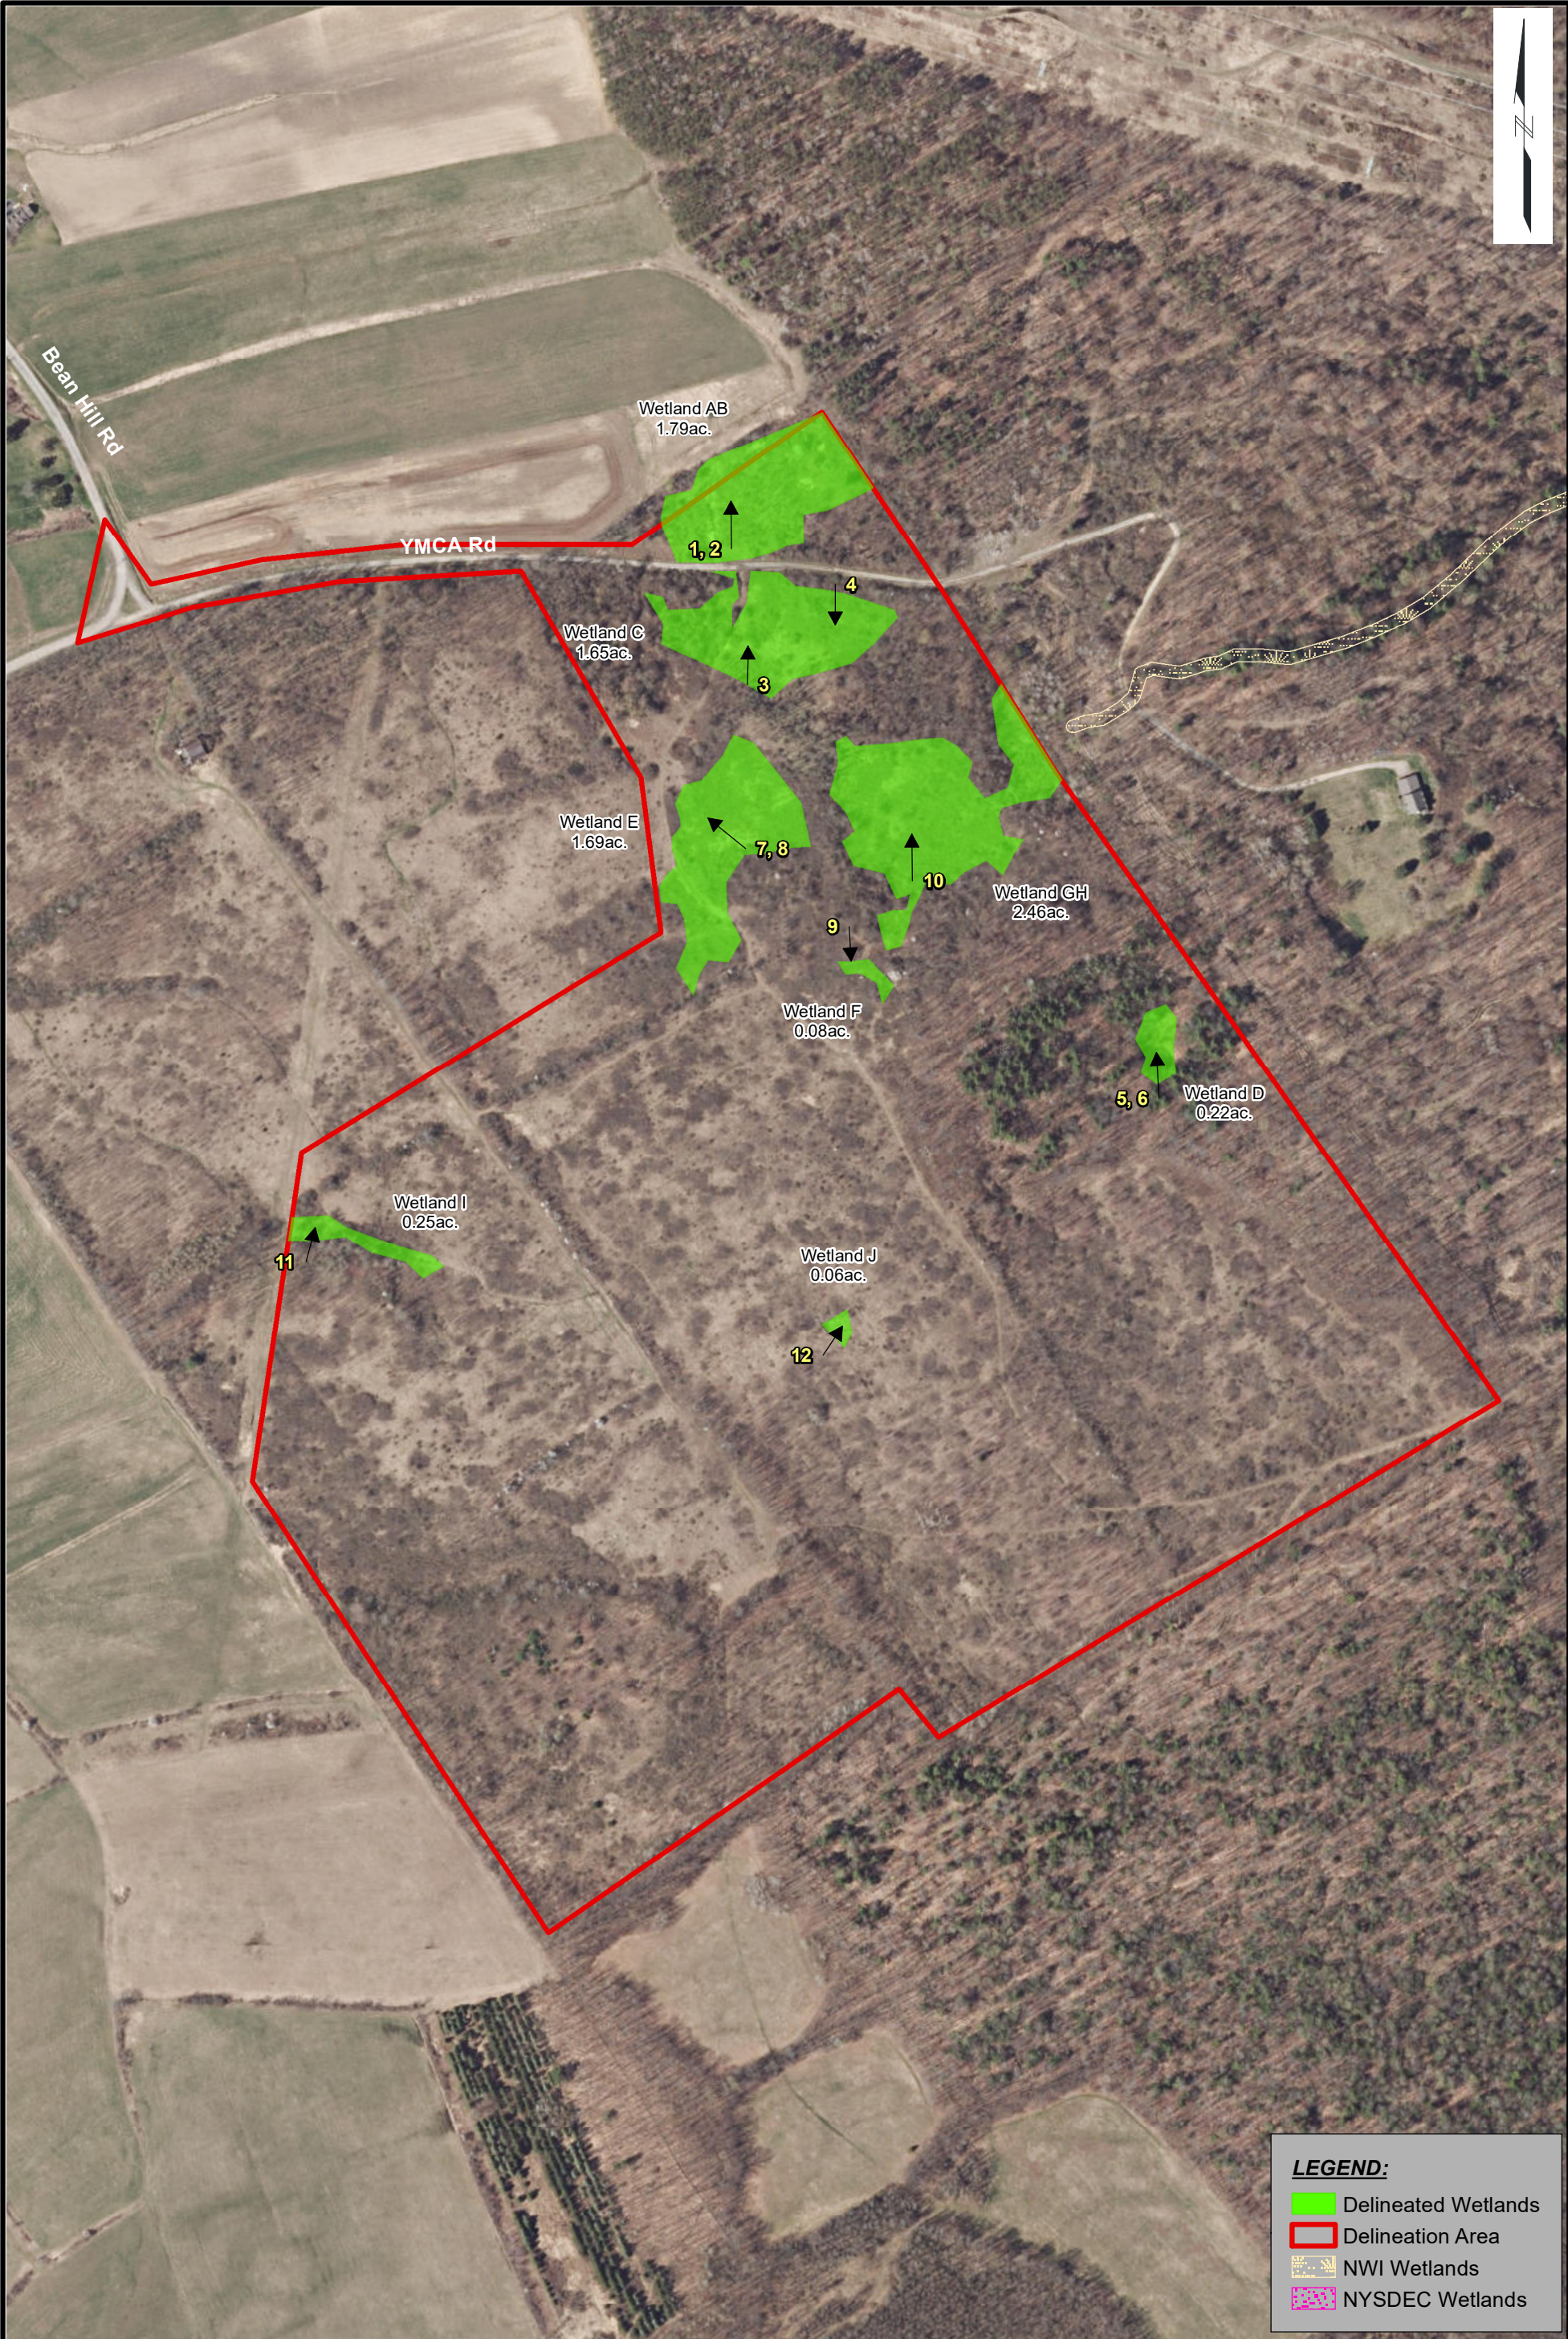
Fig. 1

GEI assessed the site on October 28, 29, and 30, 2020 and November 19 and 20, 2020 and found approximately nine (9) percent of the Site (8.2-acres) consists of wetlands (Figure 1). Eight (8) wetlands were delineated on the Site, labelled Wetlands AB, C, D, E, F, GH, I, and J. The wetland areas identified within the Site and their Cowardin description is summarized in Table 1 below and a summary of each of these wetlands follows.

WETLAND DELINEATION
MAP

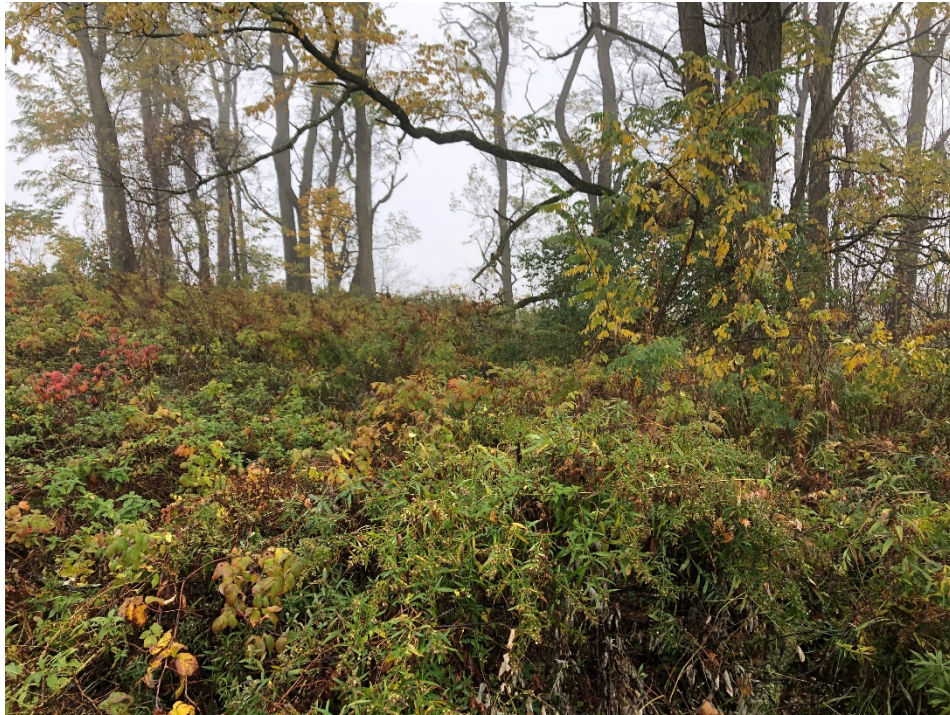
Wetland AB is a forested wetland located in the northeastern corner of the Site (Figure 1 and Appendix A, Photos 1 and 2). The forested wetland consists of a canopy of American elm (*Ulmus americana*) with a sparse understory of staghorn sumac (*Rhus typhina*) and gray dogwood (*Cornus racemosa*). The herbaceous layer within the wetland is dominated by wrinkle-leaf goldenrod (*Solidago rugosa*) and flat-top goldenrod (*Euthamia graminifolia*). The soil layer from 0 to 9 inches deep in Wetland AB exhibits the hydric soil indicator Redox Dark Surface (F6), a hue of 10YR with a matrix/chroma of 3/2 and 8 percent redox concentrations of color 5YR 3/4. The wetland sample point also exhibits positive wetland hydrology due to the presence of drainage patterns and geomorphic position. This wetland is thought to be hydrologically connected to Wetland C via a culvert that passes under the road.

Photo No. 1 – View of Wetland AB facing north

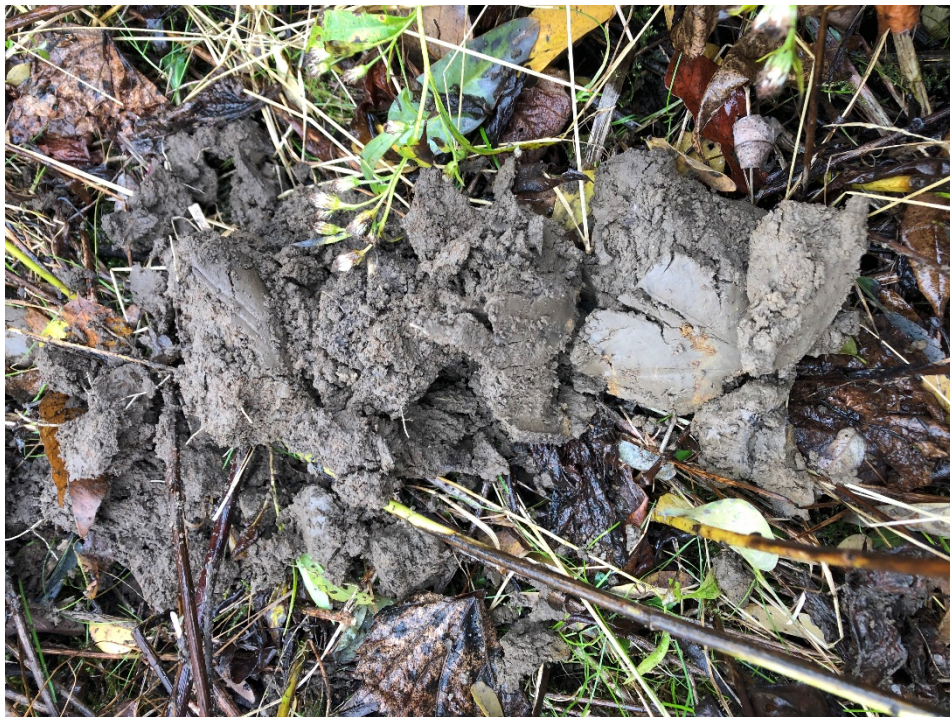
Photo No. 2 – View of soil from Wetland AB

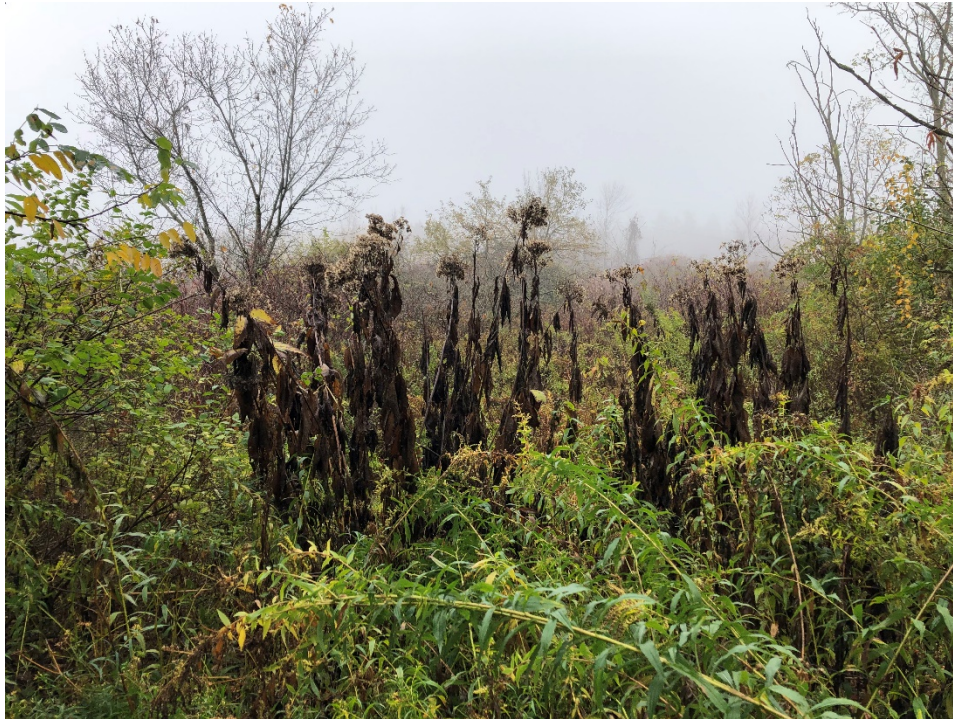
Wetland C is a scrub/shrub wetland located in the northern portion of the Site (Figure 1 and Appendix A, Photos 3 and 4). The wetland consists of a sparse canopy of American elm (*Ulmus americana*) with a dense understory of gray dogwood (*Cornus racemosa*) and silky dogwood (*Cornus amomum*). The herbaceous layer within the wetland is dominated by wrinkle-leaf goldenrod (*Solidago rugosa*) and flat-top goldenrod (*Euthamia graminifolia*). Soils within the wetland display the Redox Dark Surface (F6) hydric indicator in the soil layer from 0 to 9 inches deep, a hue of 10YR with a matrix/chroma of 3/2 and 8 percent redox concentrations of color 5YR 3/4. The wetland sample point also exhibits positive wetland hydrology due to the presence of drainage patterns and geomorphic position. This

Photo No. 3 – View of Wetland C facing north

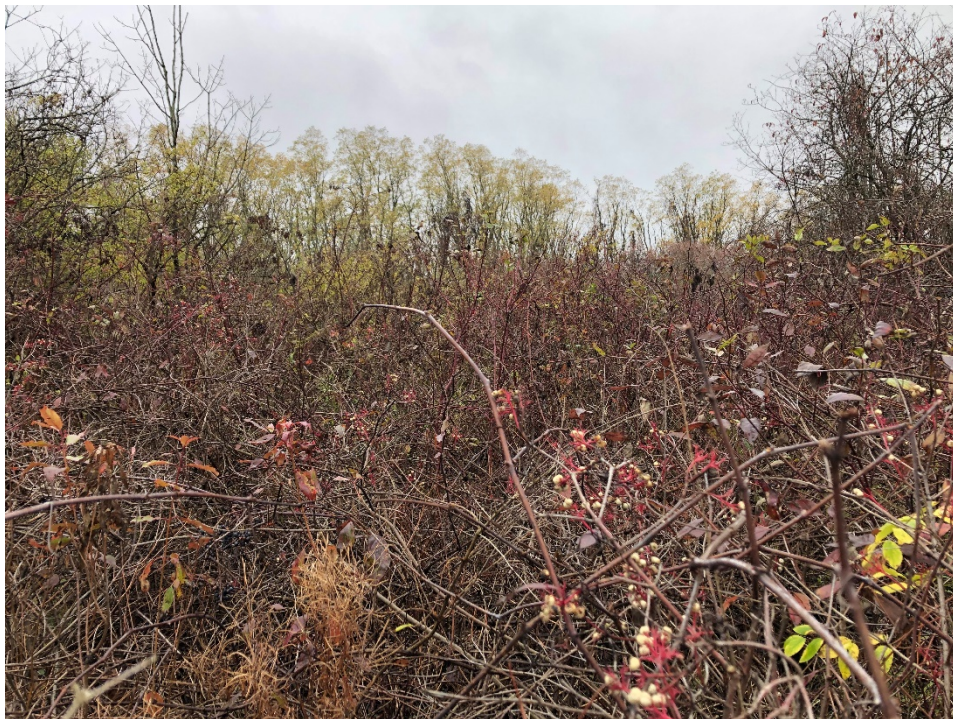
Photo No. 4 – View of Wetland C facing south

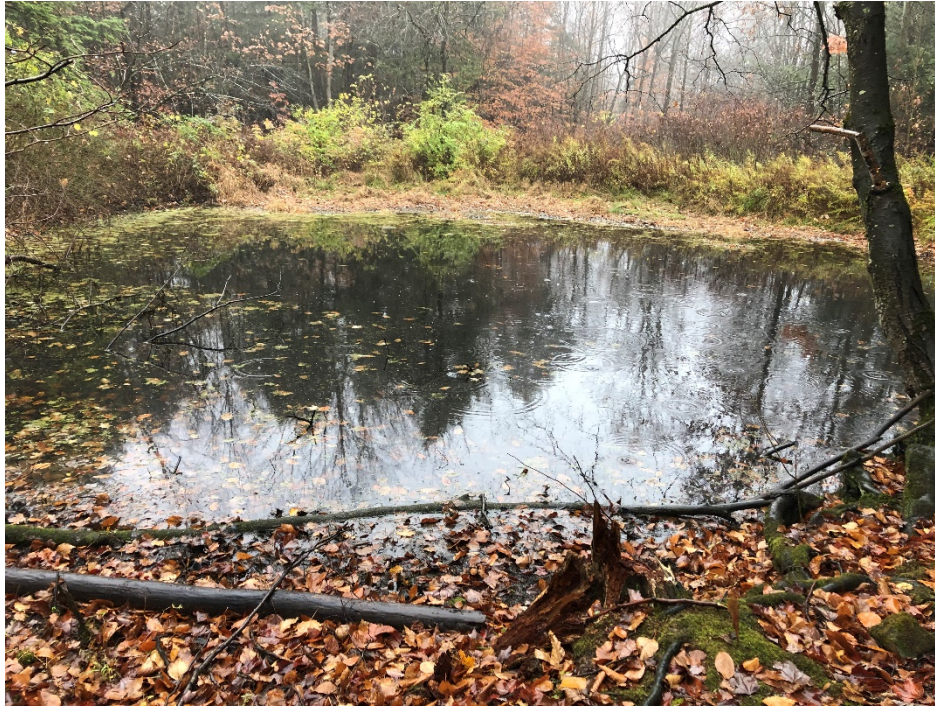
Wetland D is an isolated, semi-permanent depression surrounded by emergent wetland plants located in the central-eastern portion of the Site (Figure 1 and Appendix A, Photos 5 and 6). Herbaceous cover within the wetland is dominated by sensitive fern (*Onoclea sensibilis*), spotted jewelweed (*Impatiens capensis*), and duckweed (*Lemna minor*) was found floating on the surface. Wetland D exhibits the Depleted Matrix (F3) hydric soil indicator in the soil layer from 0 to 6 inches deep, a hue of 10YR with a matrix/chroma of 4/2, and 10 percent prominent redox concentrations. Wetland hydrology indicators are also present in the form of geomorphic position and saturation visible on aerial imagery. Surface water is present in the southern portion of Wetland D. This wetland is thought to be hydrologically isolated.

Photo No. 5 – View of Wetland D facing north

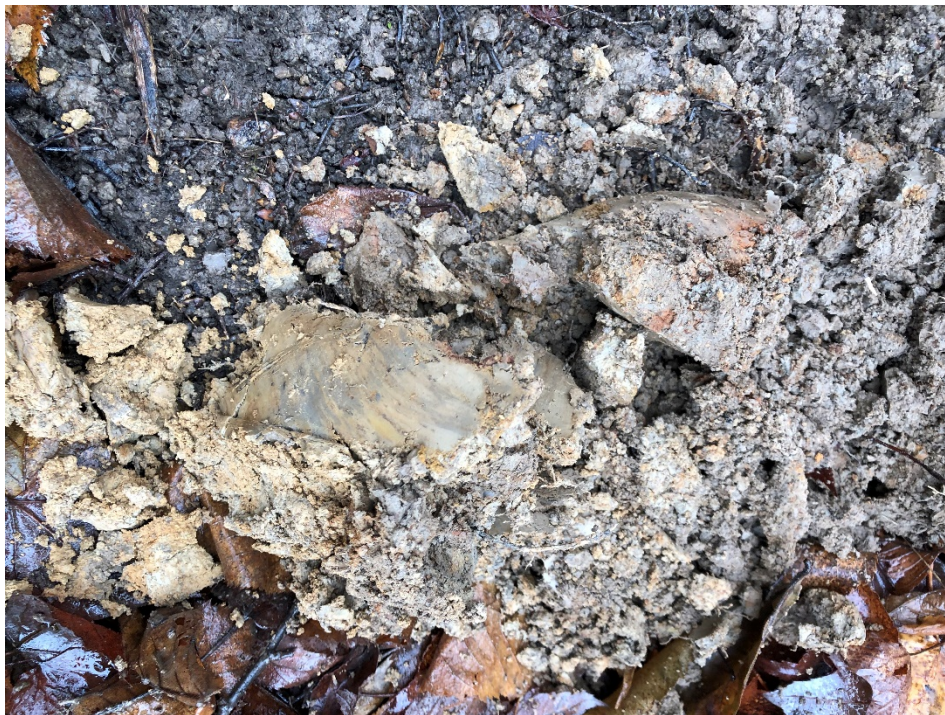
Photo No. 6 – View of soil from Wetland D

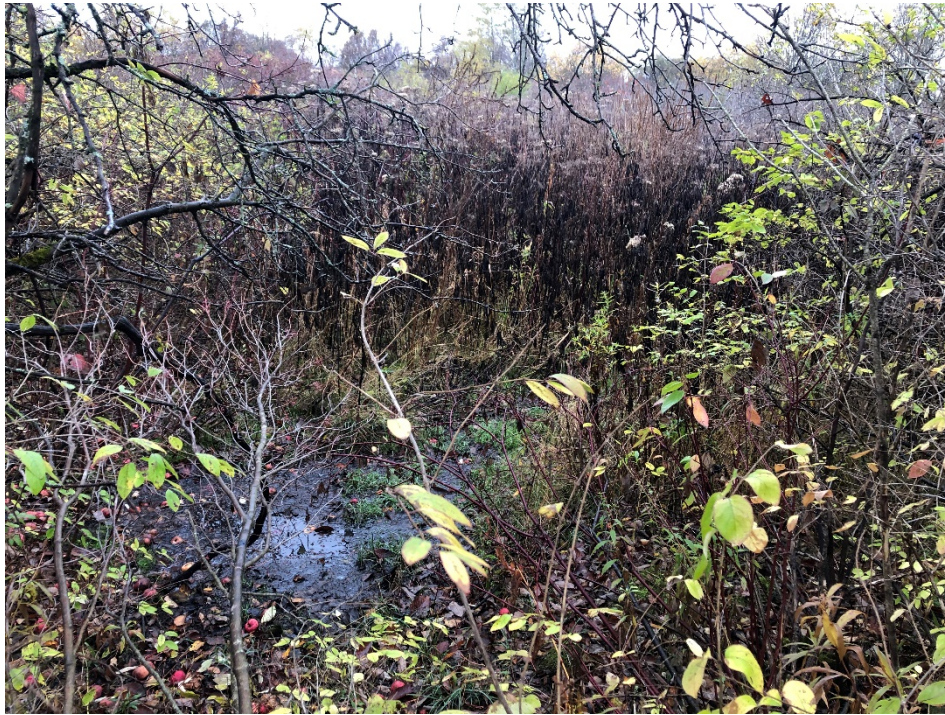
Wetland E is a scrub/shrub wetland situated in the northwestern portion of the Site (Figure 1 and Appendix A, Photos 7 and 8). Understory cover within the wetland is dominated by gray dogwood (*Cornus racemosa*) and silky dogwood (*Cornus amomum*). Herbaceous cover within the wetland includes sensitive fern (*Onoclea sensibilis*) and giant goldenrod (*Solidago gigantea*). Soils within the wetland display the Redox Dark Surface (F6) hydric indicator in the soil layer from 8 to 12 inches deep, a hue of 10YR with a matrix/chroma of 3/2 and 5 percent redox concentrations of color 7.5YR 3/4. The wetland sample point also exhibits positive wetland hydrology due to geomorphic position and passing the FAC-Neutral Test.

Photo No. 7 – View of Wetland E facing northwest

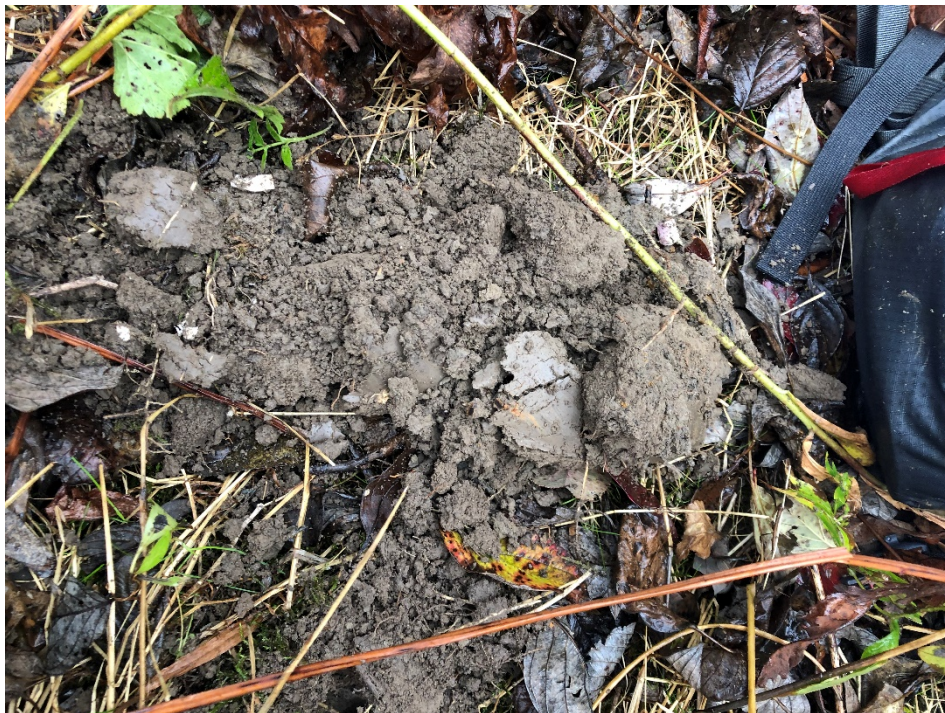
Photo No. 8 – View of soil from Wetland E

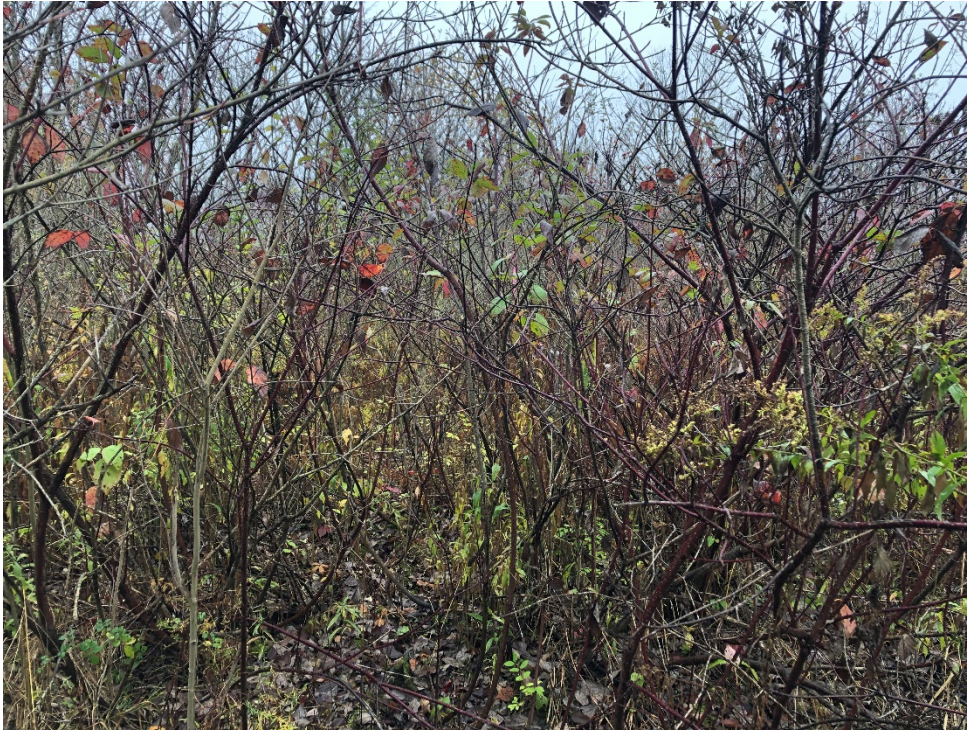
Wetland F is a small, isolated scrub/shrub wetland situated in the central-eastern portion of the Site (Figure 1 and Appendix A, Photo 9). The understory cover within the wetland consists of gray dogwood (*Cornus racemosa*) and silky dogwood (*Cornus amomum*). Herbaceous cover within the wetland includes sensitive fern (*Onoclea sensibilis*) and giant goldenrod (*Solidago gigantea*) and flat-top goldenrod (*Euthamia graminifolia*). Soils within the wetland display the Redox Dark Surface (F6) hydric indicator in the soil layer from 8 to 12 inches deep, a hue of 10YR with a matrix/chroma of 3/2 and 5 percent redox concentrations of color 7.5YR 3/4. The wetland sample point also exhibits positive wetland hydrology due to geomorphic position and passing the FAC-Neutral Test.

Photo No. 9 – View of Wetland F facing south

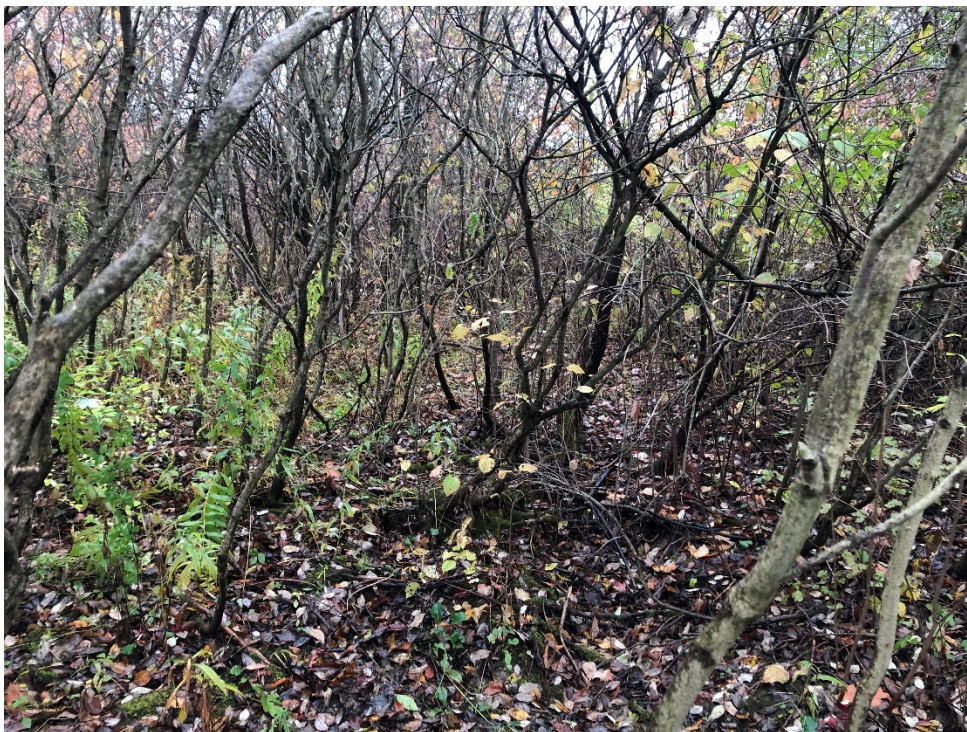
Wetland GH is a scrub/shrub wetland along the eastern edge of the Site (Figure 1 and Appendix A, Photo 10). The wetland consists of a sparse canopy of green ash (*Fraxinus pennsylvanica*) and red oak (*Quercus rubra*) with a dense understory of silky dogwood (*Cornus amomum*) and Morrow's honeysuckle (*Lonicera morrowii*). The herbaceous layer within the wetland is dominated by giant goldenrod (*Solidago gigantea*). Soils within the delineated wetland display the Depleted Matrix (F3) hydric indicator in the soil layer from 8 to 14 inches deep, a hue of 10YR with a matrix/chroma of 4/2 and 5 percent redox concentrations of color 7.5YR 3/3. The wetland sample point also exhibits positive wetland hydrology due to geomorphic position. This wetland continues off site to the northeast where

it drains through a culvert under a driveway. Topographic maps indicate this is the head of a tributary to South Chuctanunda Creek.

Photo No. 10 – View of Wetland GH facing north

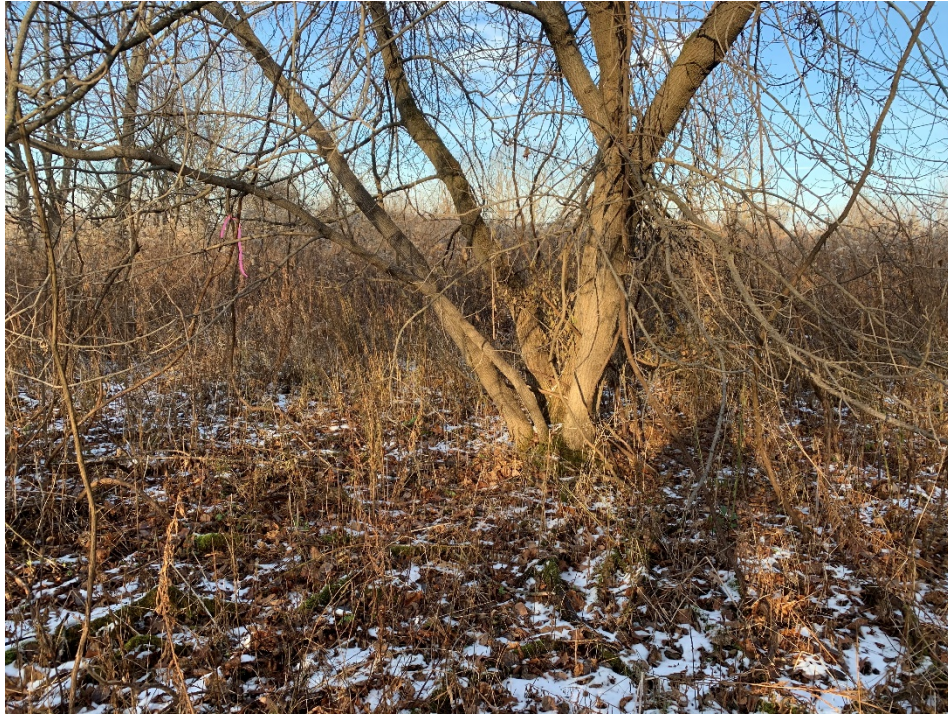
Wetland I is a scrub/shrub wetland in the central western portion of the Site (Figure 1 and Appendix A, Photo 11). The wetland consists of a sparse canopy of box elder (*Acer negundo*) and red maple (*Acer rubrum*) with a dense understory of silky dogwood (*Cornus amomum*). The herbaceous layer within the wetland is dominated by giant goldenrod (*Solidago gigantea*). Soils within the delineated wetland display the Depleted Matrix (F3) hydric indicator in the soil layer from 0 to 8 inches deep, a hue of 10YR with a matrix/chroma of 3/2. The wetland sample point also exhibits positive wetland hydrology due to geomorphic position and drainage patterns. This wetland continues off site to the west. Topographic maps indicate this wetland would drain to a tributary of Schoharie Creek.

Photo No. 11 – View of Wetland I

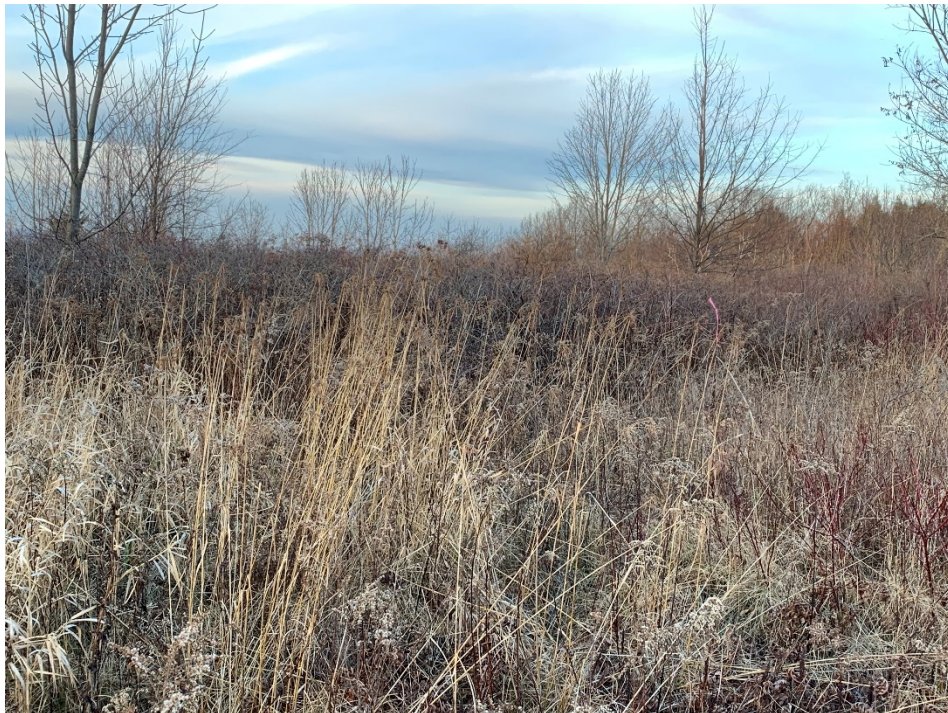
Wetland J is an isolated scrub/shrub wetland in the central southern portion of the Site (Figure 1 and Appendix A, Photo 12). The wetland consists of a sparse canopy of green ash (*Fraxinus pennsylvanica*) with a dense understory of silky dogwood (*Cornus amomum*) and gray dogwood (*Cornus racemosa*). The herbaceous layer within the wetland is dominated by giant goldenrod (*Solidago gigantea*). Soils within the delineated wetland display the Depleted Matrix (F3) hydric indicator in the soil layer from 0 to 12 inches deep, a hue of 2.5Y with a matrix/chroma of 5/2 and 15 percent redox concentrations of color 10YR 3/6. The wetland sample point also exhibits positive wetland hydrology due to geomorphic position and passing the FAC-Neutral Test. This wetland is thought to be hydrologically isolated.

Photo No. 12 – View of Wetland J
